## **Realistic Safe-Separation Distance Determination for Mass Fire Hazards**

by  
Thomas L. Boggs  
*New Directions Technology, Inc.*  
*Ridgecrest, CA 93555*

**MARCH 2013**

NAVAL AIR WARFARE CENTER WEAPONS DIVISION  
China Lake, CA 93555-6100

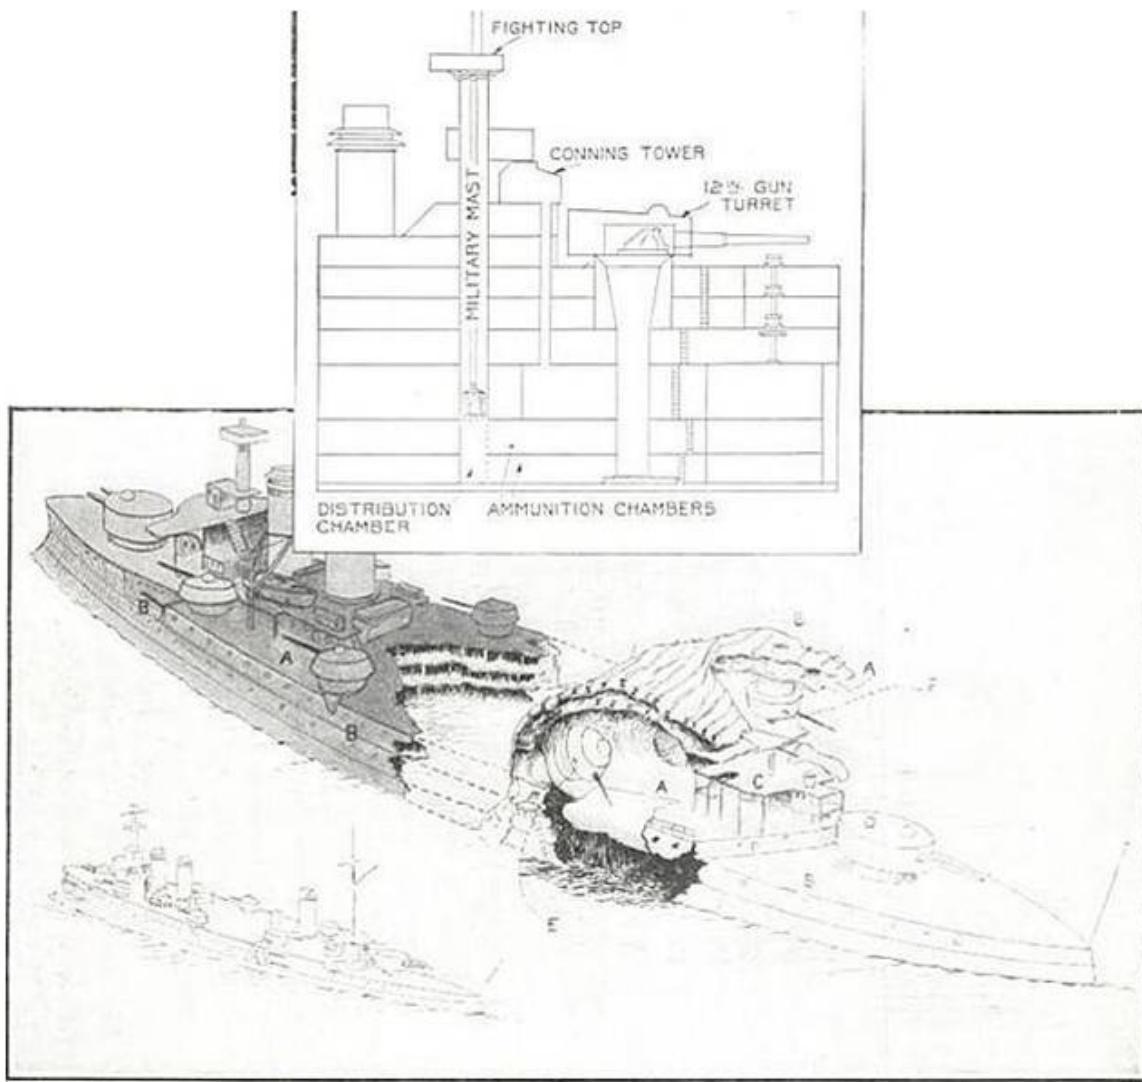
On 25 September 1911 while in the Toulon harbor, the magazines of the *Liberte* exploded. The chain reaction explosions of the magazine followed frantic firefighting after auto-ignition of the nitrocellulose gun propellant in a forward magazine. The violence of the explosion amidships tossed the upper decks back, curled and flattened like a banana peel as indicated in Figure 5.

FIGURE 5. Result of the Explosion Aboard the *Liberte*, 25 September 1911.

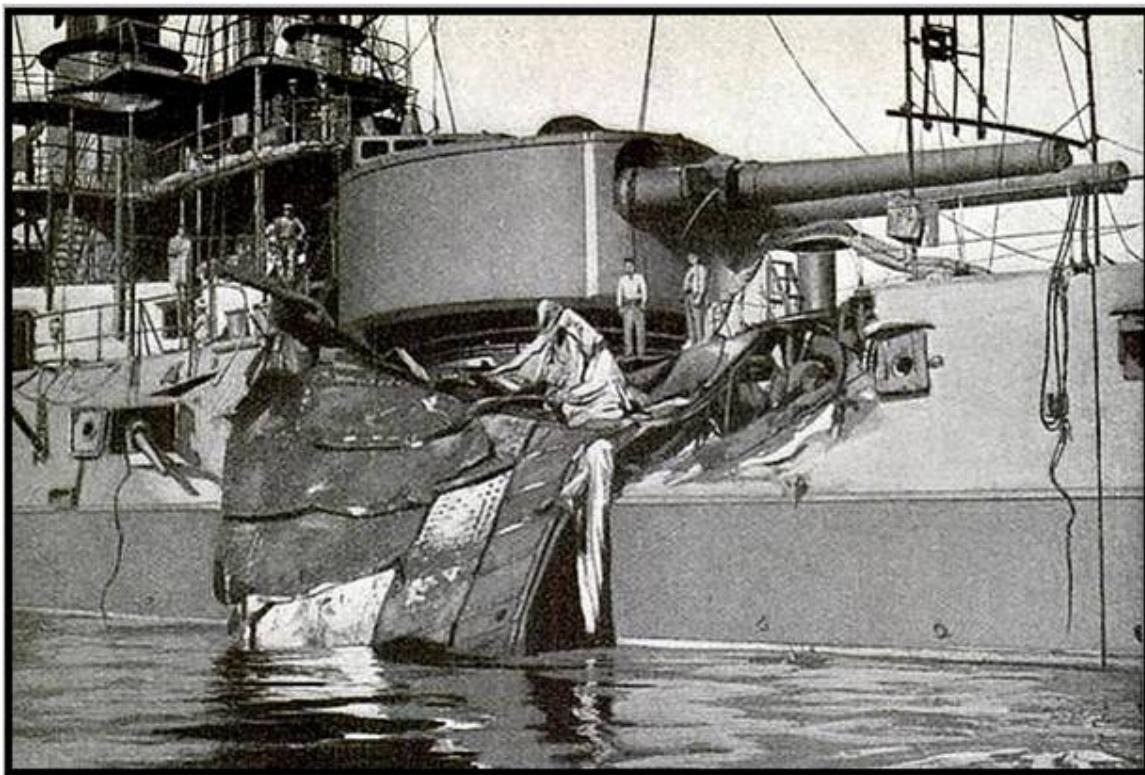
Sections of the *Liberte* were hurled outward with great force. Figure 6 shows a large piece of the *Liberte* embedded in the *Republique*, which was anchored nearby.

FIGURE 6. Sections of the *Liberte*'s Armor Plate Embedded in the *Republique*, Which was Anchored Nearby.

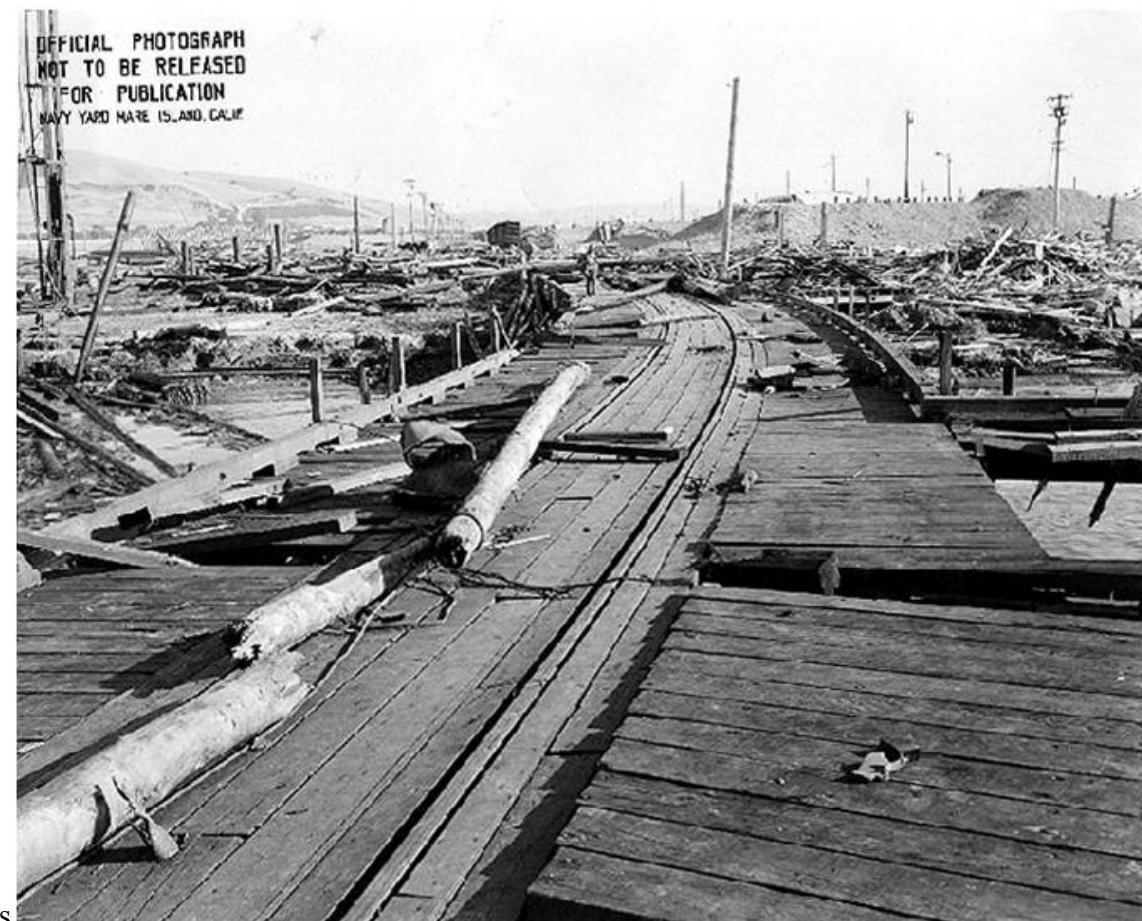
FIGURE 11. Damage at Port Chicago, CA.  
View looking south from ship pier.

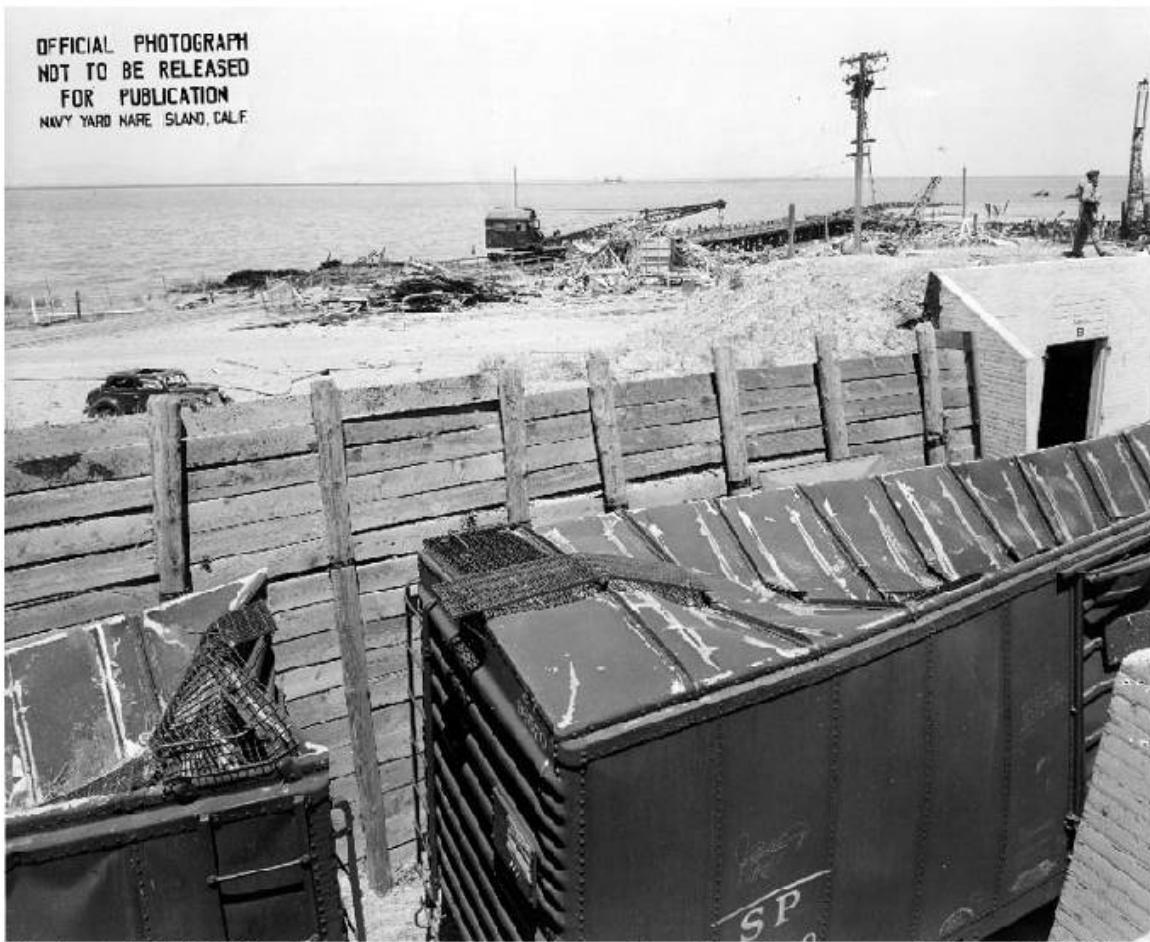
Photo # NH 96822 Damage at Port Chicago, Ca. View looking north from BM138.

FIGURE 12. Damage to Railcars in Revetments That Were Waiting to be Unloaded.

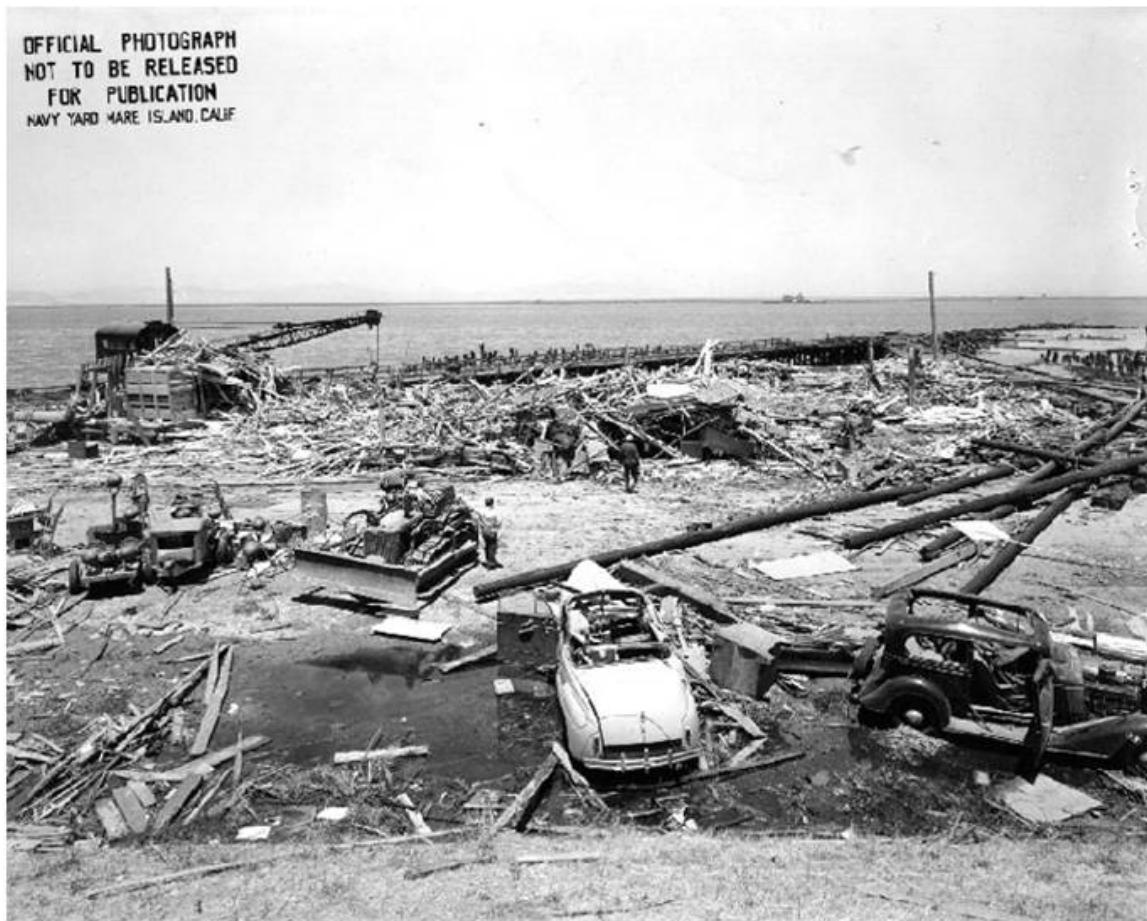
FIGURE 13. Damage at Port Chicago, CA.  
View looking north toward pier.

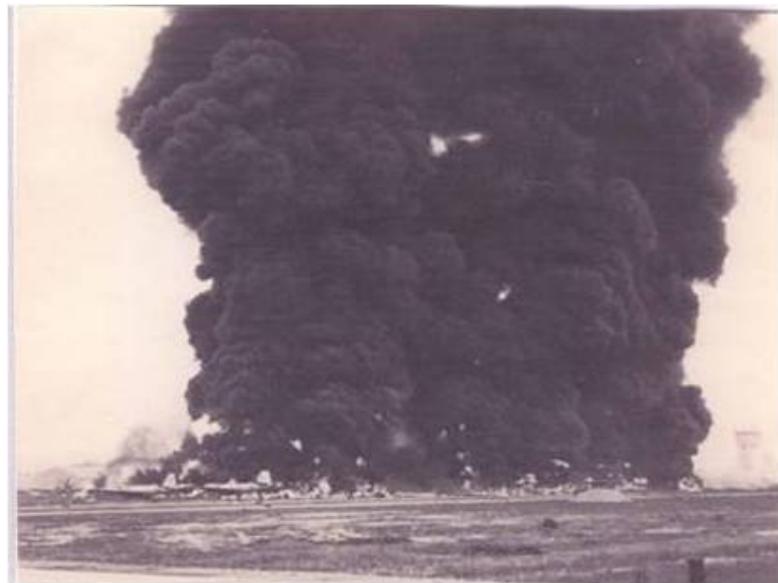
FIGURE 14. Conflagration at Bien Hoa AFB, South Vietnam,  
16 May 1965, as Seen From the Ground.

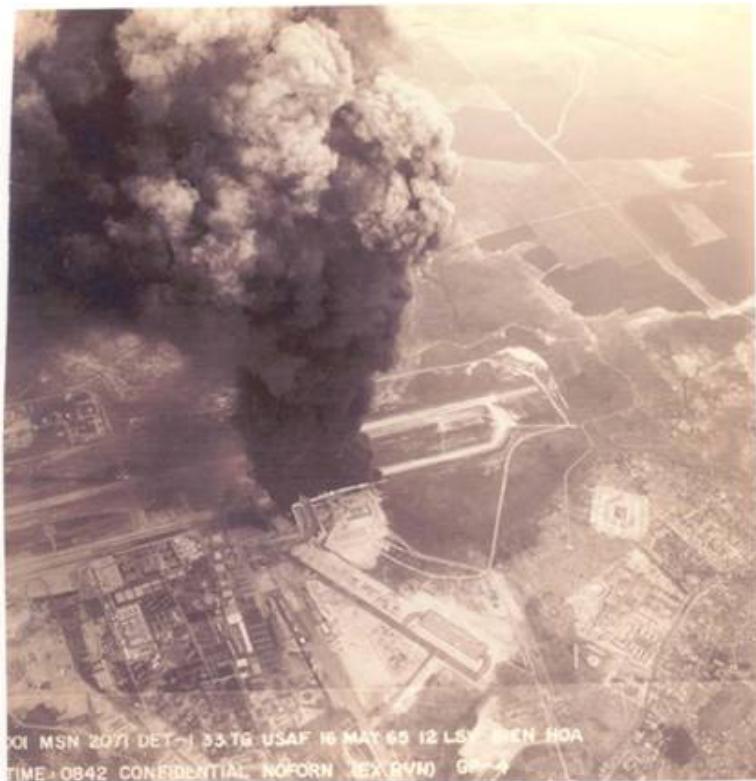
FIGURE 15. Conflagration at Bien Hoa AFB, South Vietnam,  
16 May 1965, as Seen From the Air.

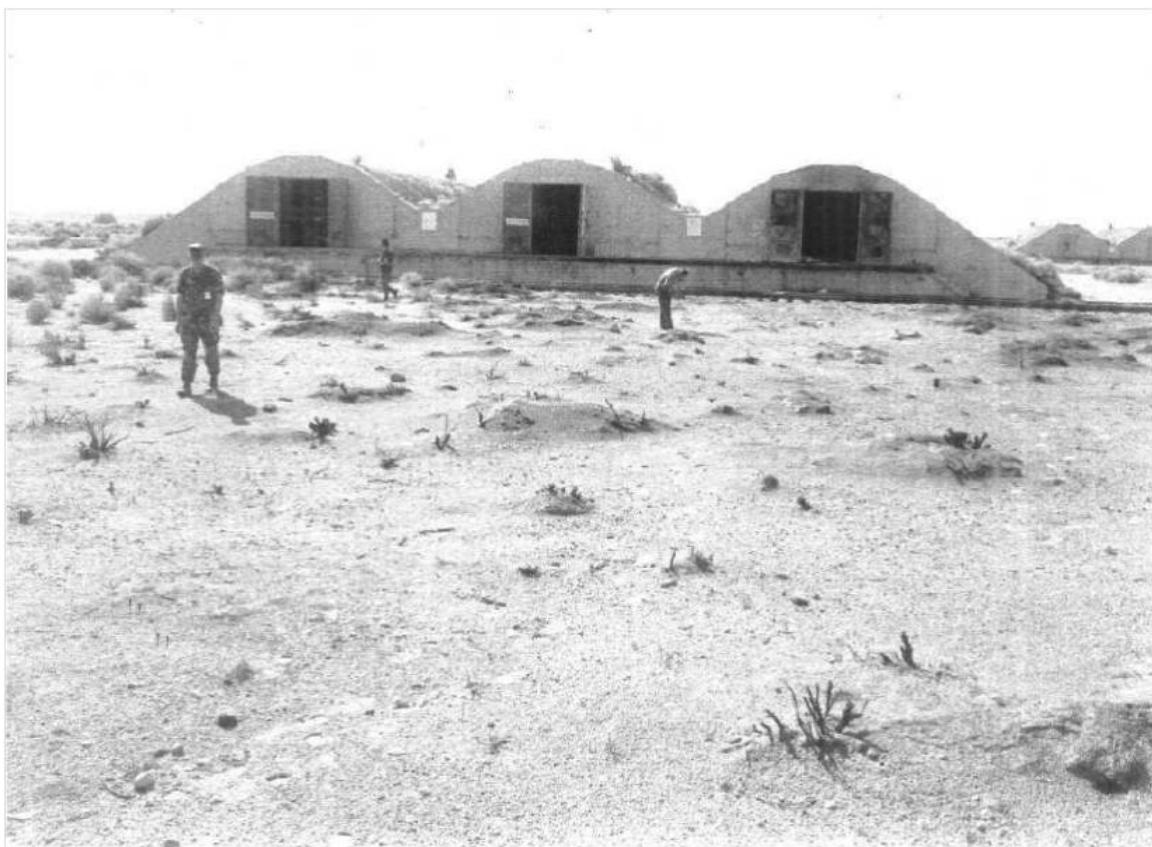
A magazine fire involving 30,715 pounds of Navy propelling charges occurred in Magazine 116-14-E at the Hawthorne AAP on 9 August 1989. The fire occurred in a Navy triple-arch magazine that was built in the 1943 to 1945 timeframe. The facility consisted of three separate earth-covered igloos that shared a common head wall and loading dock. Each igloo was concrete and arched on its long axis. It was 80 feet long x 25 feet wide and 12 feet high at the top of the arch. Each igloo was separated from the adjacent igloo by 13 feet of earth to a height of 6 feet above the floor level. It then decreased to no less than 2 feet of earth cover over the igloo roof. Each igloo had 4-foot wide double doors that opened onto a 6-foot-wide concrete loading dock. The doors were wood covered with 22-gauge steel. Each door had a 12- by 18-inch vent in the lower portion of the door. There was also a rear stack ventilator 15 inches in diameter that extended 30 inches above the level of the earth cover. The ventilator was capped with a vent cap weighing 195 pounds and made of glazed ceramic, metal, and screening. It set on top of the stack but was not fastened. Figure 16 shows the three earth-covered igloos (A, C, and E) making up the Magazine 116-14 after the accident. The fire occurred in unit E. Figure 17 shows the door to Magazine 116-14-E after the accident. There were no fatalities involved in this accident.

FIGURE 16. Magazine 116-14 With Igloos A, C, and E (Left to Right) After the Accident.  
Notice the burned sagebrush in front of E.

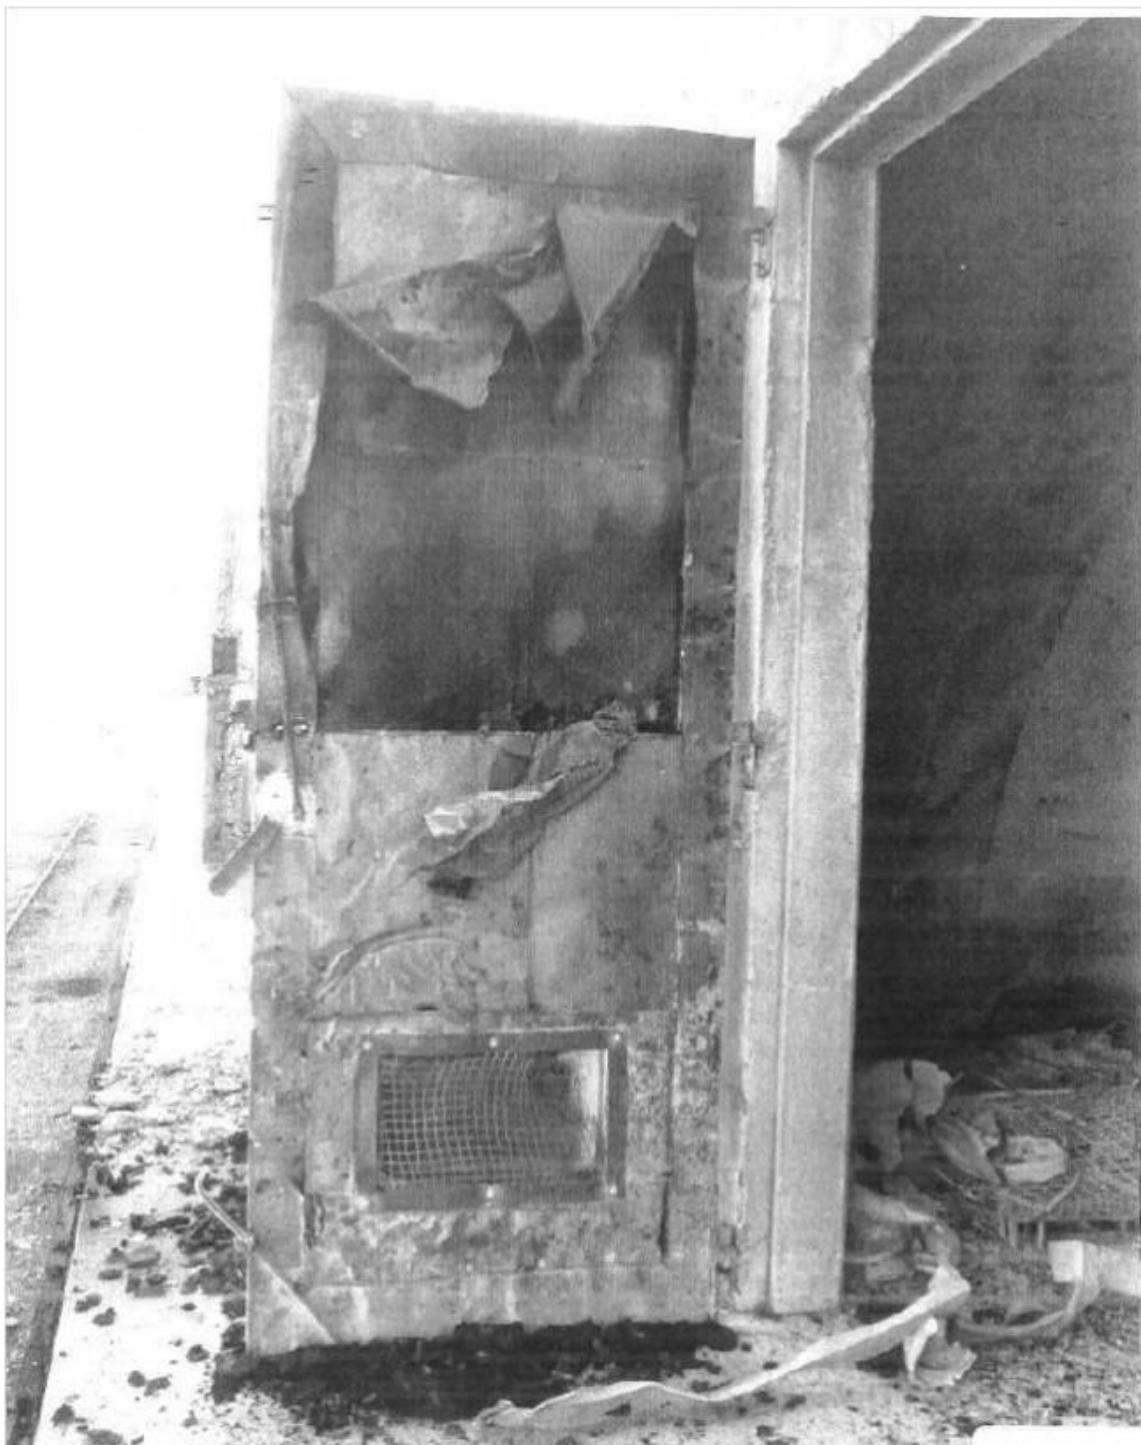
FIGURE 17. Door to Magazine 116-14-E After the Accident.

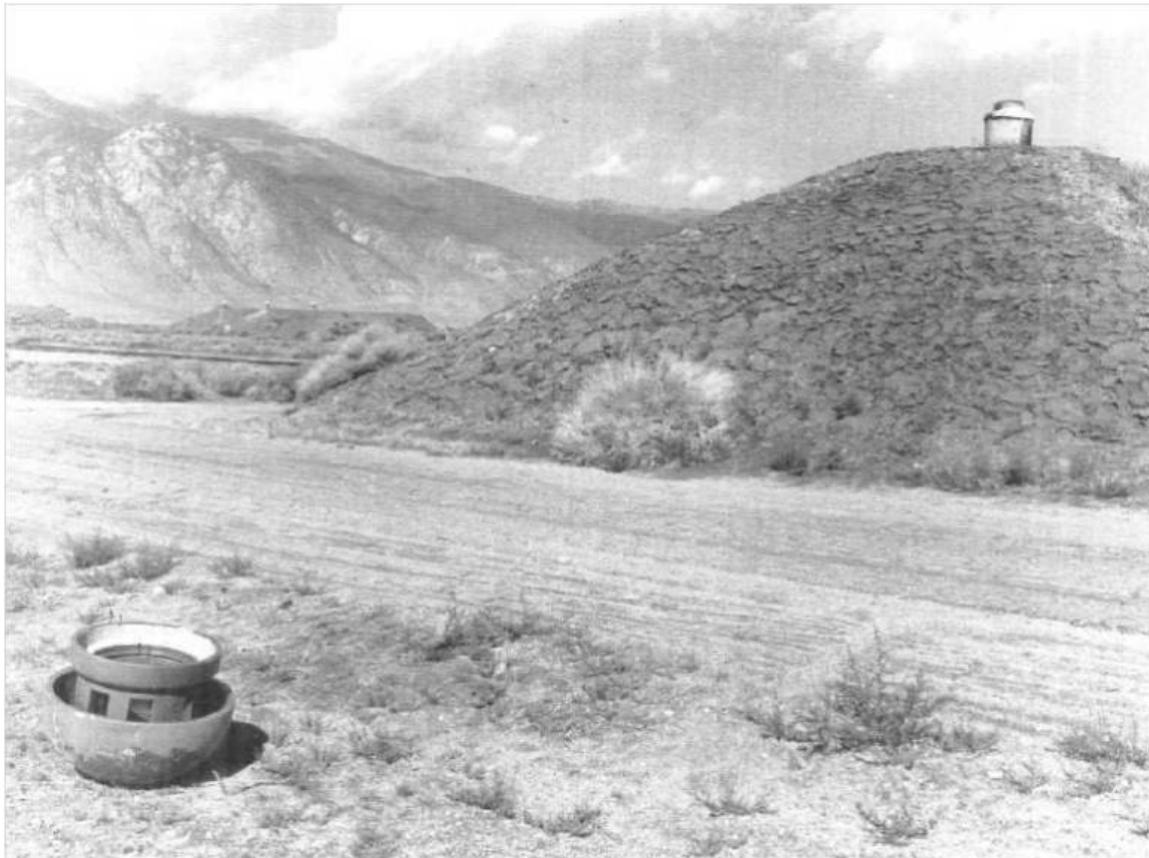
The post accident investigation indicated that the reaction was a rapid deflagration but there was no detonation. The 195-pound vent cover was found 65 feet from the magazine (Figure 18).

FIGURE 18. 195-Pound Vent Cap Found 65 Feet  
From the Magazine After the Accident.

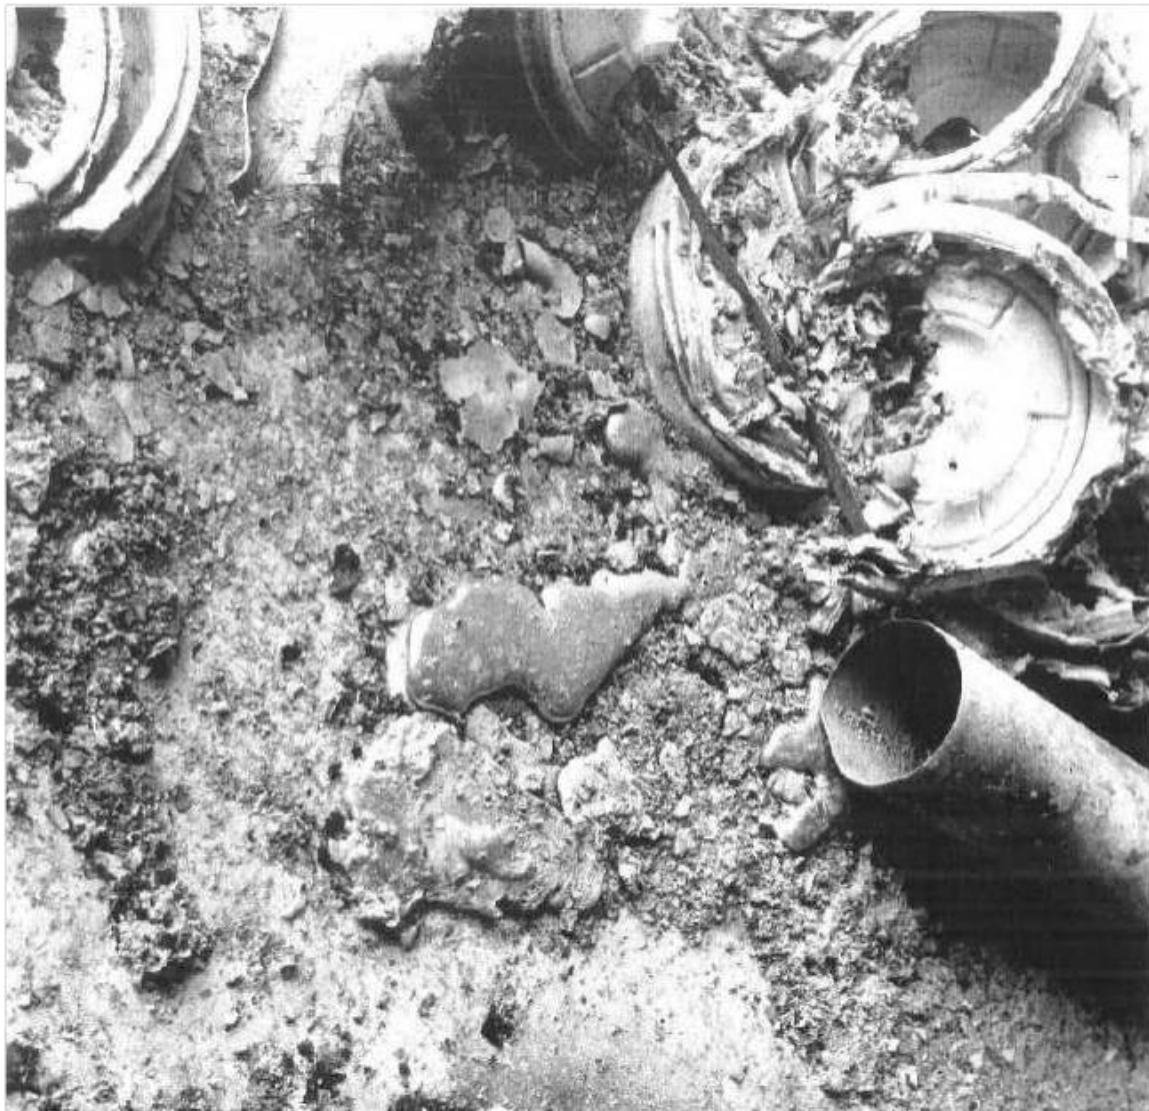
The most intense heat was at the front portion of the magazine as evidenced by slag that had been molten metal from the metal shipping containers (Figure 19). Since the shipping containers were aluminum, this indicates that the containers were exposed to temperatures of over  $660^{\circ}\text{C}$  ( $1,220^{\circ}\text{F}$ ) sufficiently long to cause melting.

FIGURE 19. Debris on Floor of Magazine Showing Slag That was Molten Aluminum.

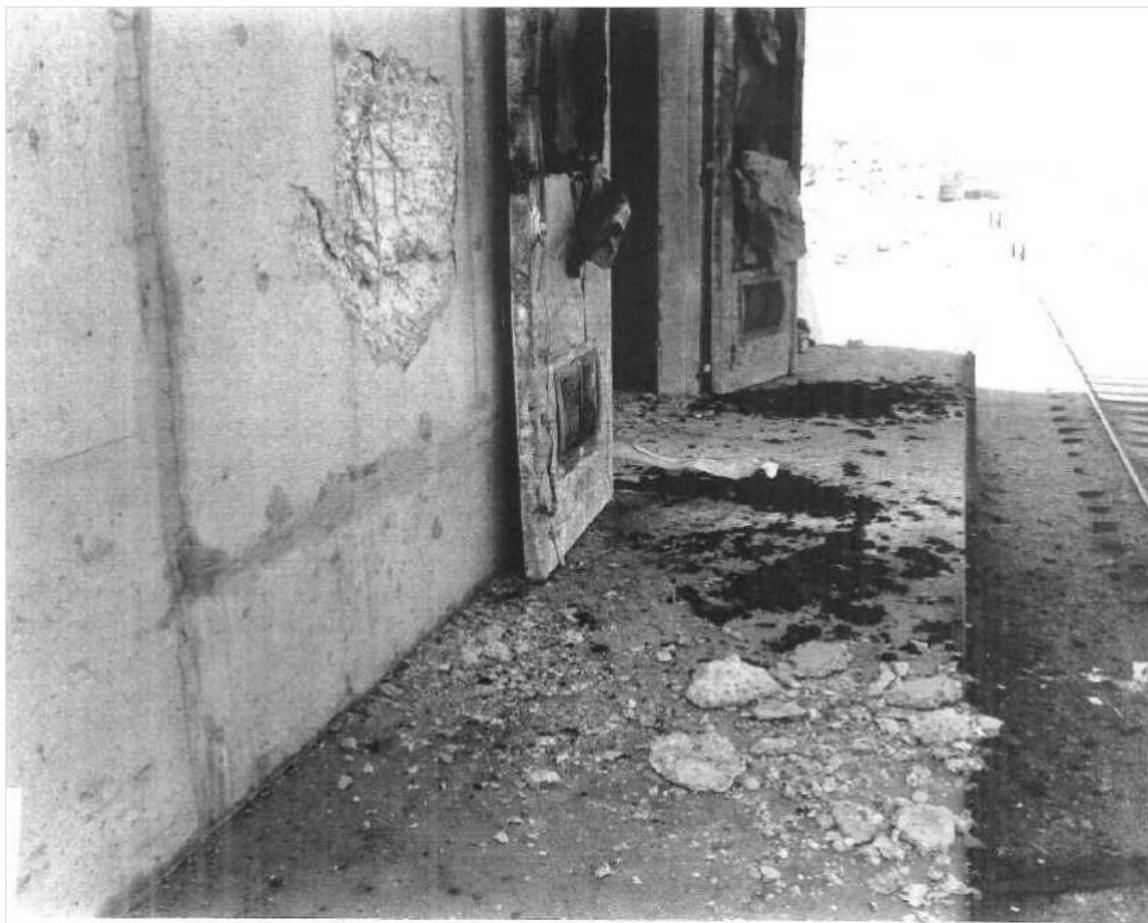
There was heavy smoke residue and spalling in various locations within the magazine. There was evidence that a 6-inch, 47-caliber case propelling charge impacted the front wall near a side wall. There was an indentation approximately 1-inch deep on the inside wall, and severe spalling on the outside of the wall opposite the impact that was about 2 feet by 2 feet and several inches deep (Figure 20). The steel rebar was exposed and concrete fragments were thrown across the entire width of the loading dock.

FIGURE 20. Damage to Front of Head Wall of Magazine 116-14-E Caused by Impact of 6-Inch, 47-Caliber Case Propelling Charge That Impacted the Rear of the Head Wall (Inside the Magazine).

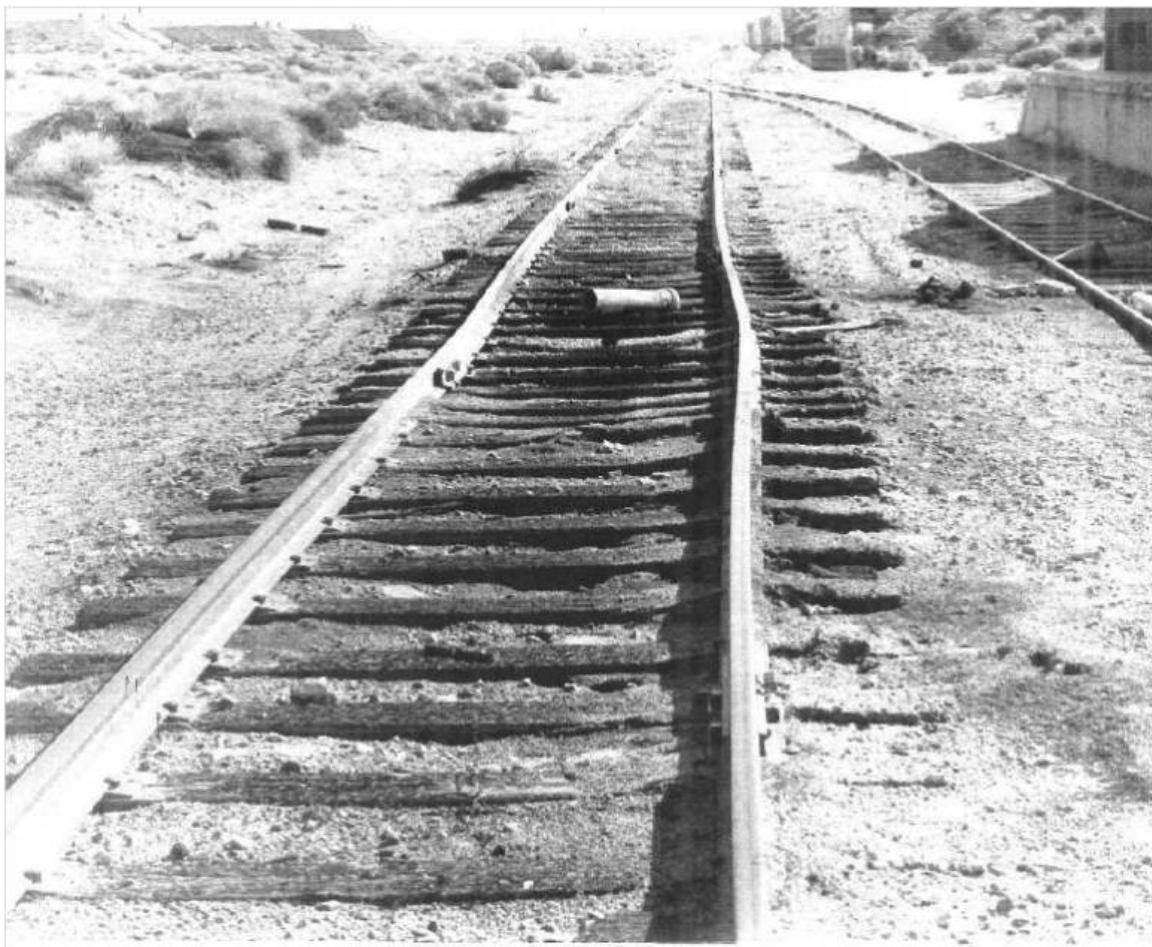
The railroad tracks directly in front of the magazine were damaged and numerous railroad ties were severely charred attesting to the intensity of the plume exiting the doors (Figure 21).

FIGURE 21. Damage to Rails and Charred Rail  
Ties in Front of Magazine 116-14-E.

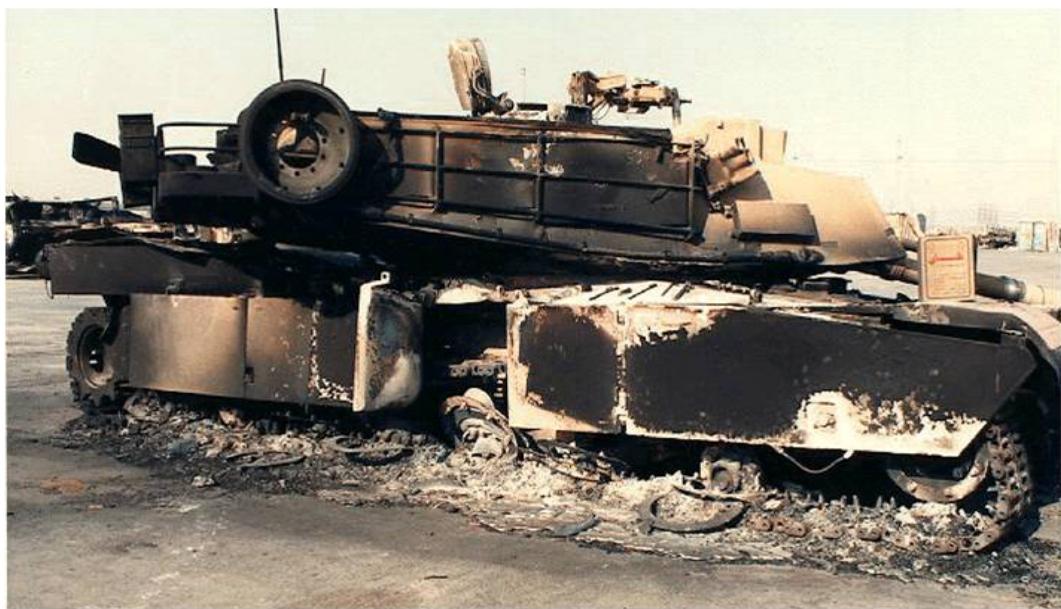
FIGURE 24. Burned-Out M1A1 Abrams Tank at Camp Doha, July 1991.

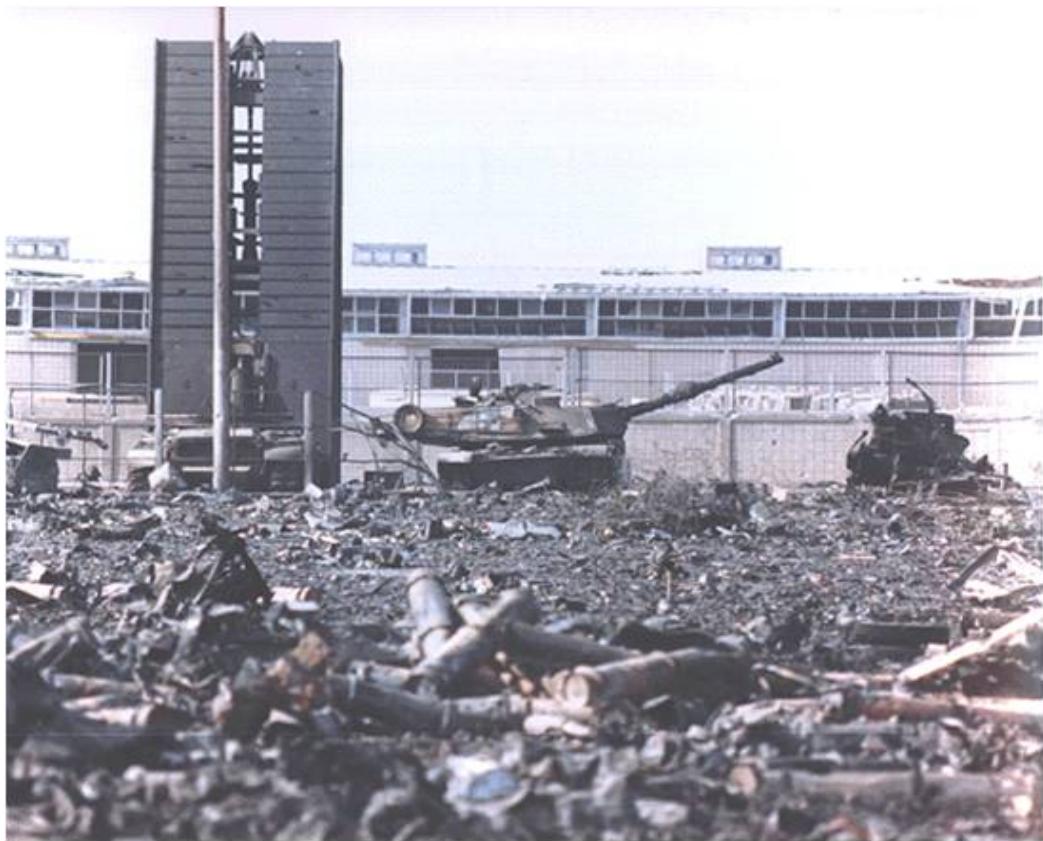
FIGURE 25. Aftermath of Doha Motor Pool Fire (View of Wash Rack Area)  
Showing Armor Hulks and Unexploded Explosive Ordnance (UXO).

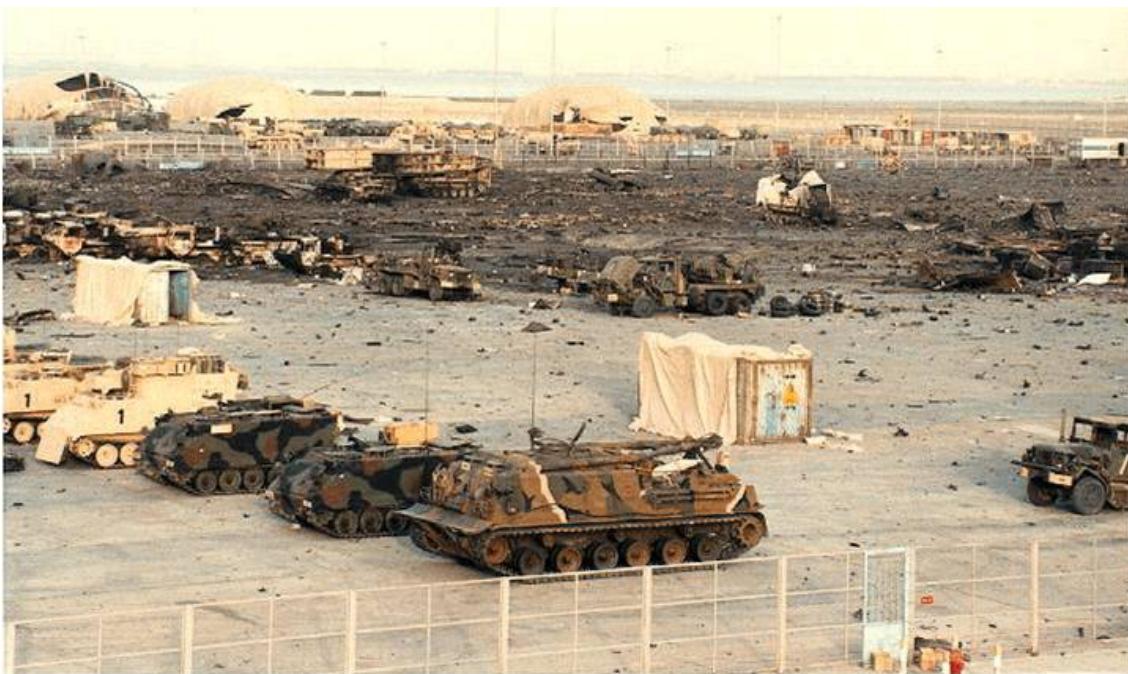
FIGURE 26. Aftermath of Camp Doha Motor Pool Fire.

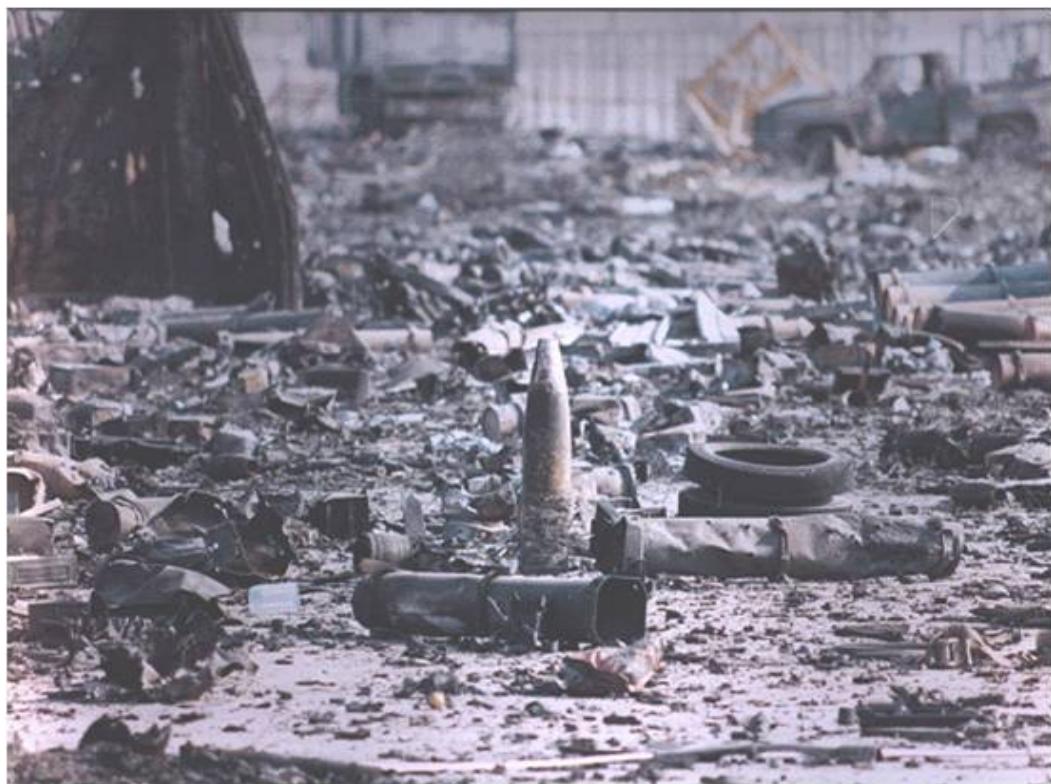
FIGURE 27. Unexploded Ordnance in Camp Doha North Compound.

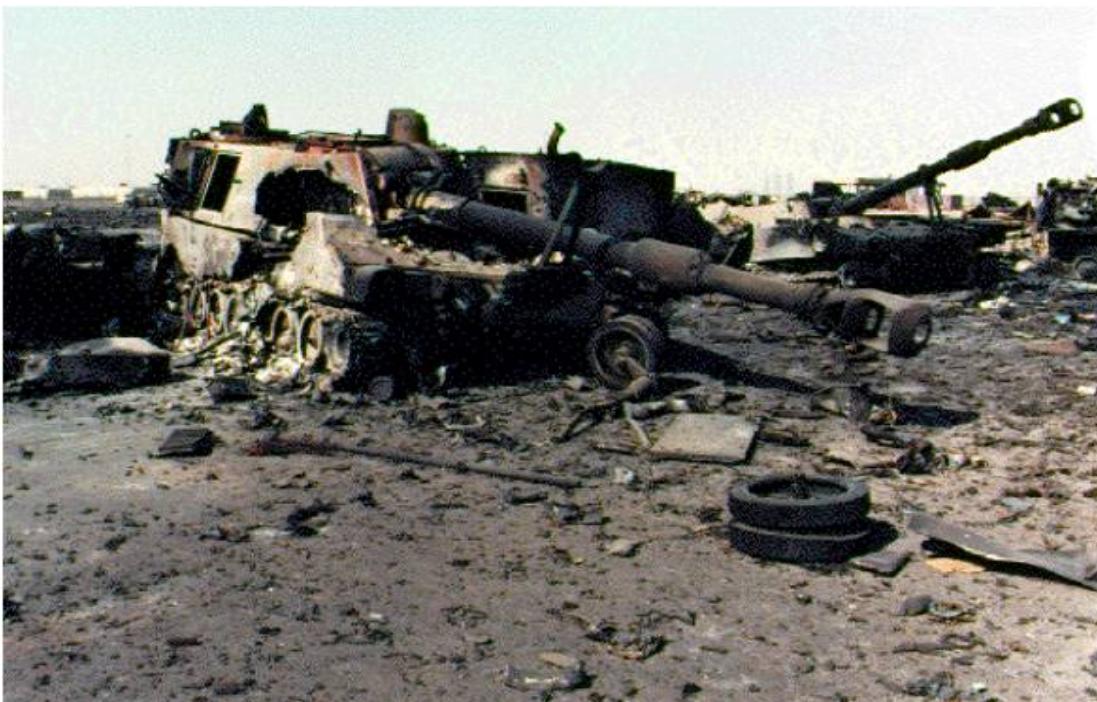
FIGURE 28. Destroyed M109 Howitzers at Camp Doha, Kuwait.

A total of 102 vehicles were destroyed, including four M1A1 Abrams tanks, and seven M109 Howitzers.

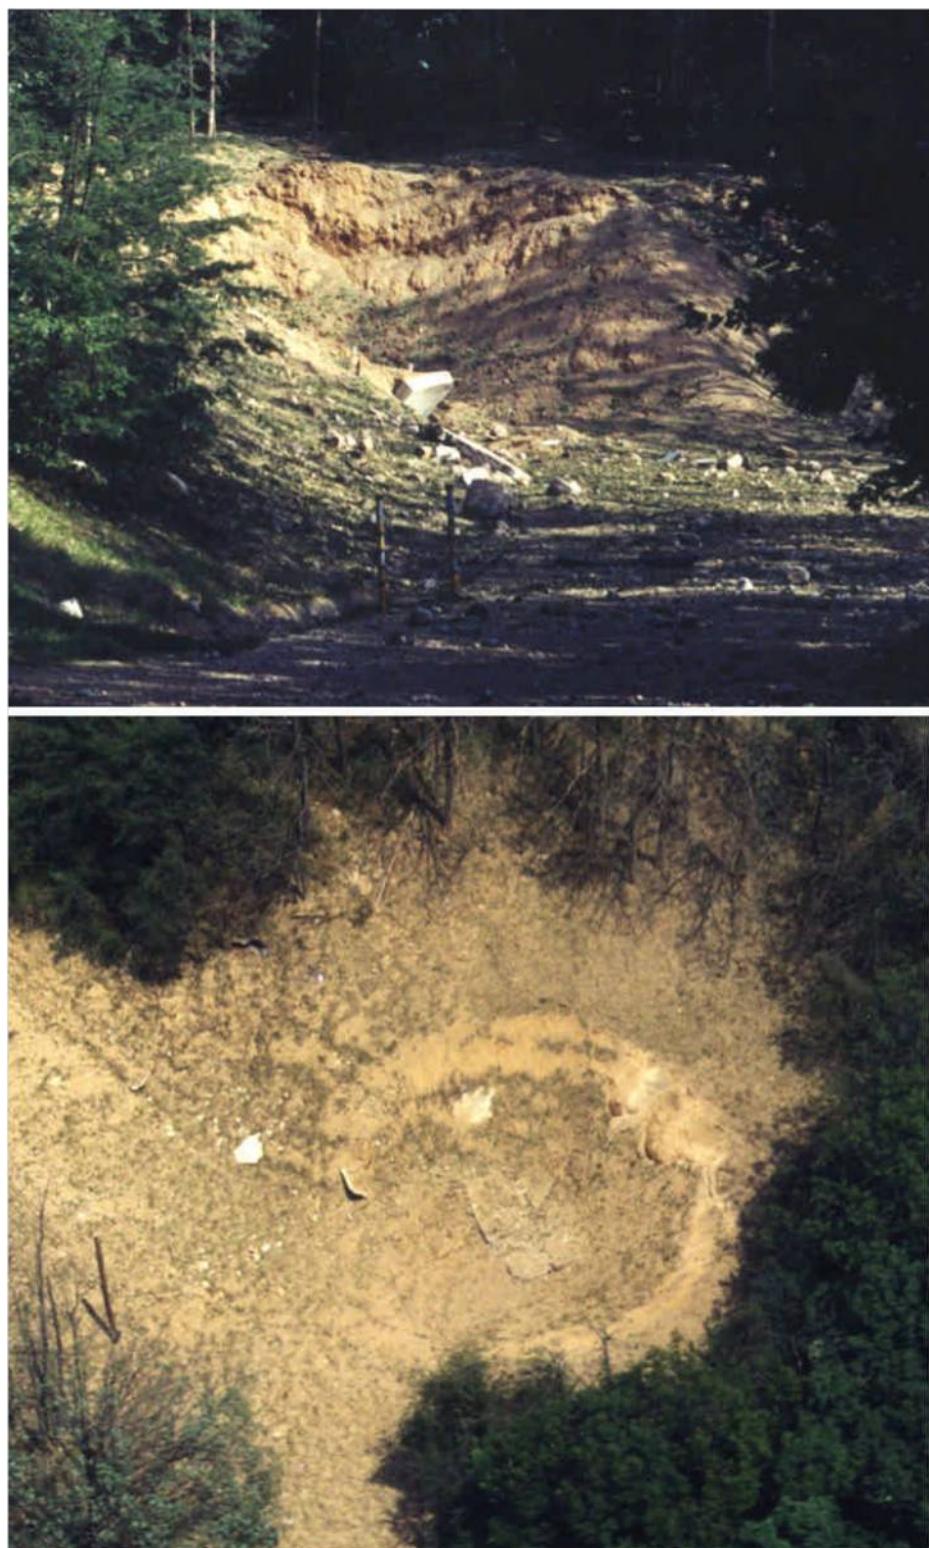
The explosions removed all of the earth covering the magazine and the structure down to the floor slab. The floor slab was broken into several pieces. Some of these pieces were driven several feet into the earth below their original location. Large portions of the floor slab were missing entirely. The average radius of the crater was 32.4 feet and no depth was given in the report.

FIGURE 30. Damage Around Where Magazine 355 Had Been Located.

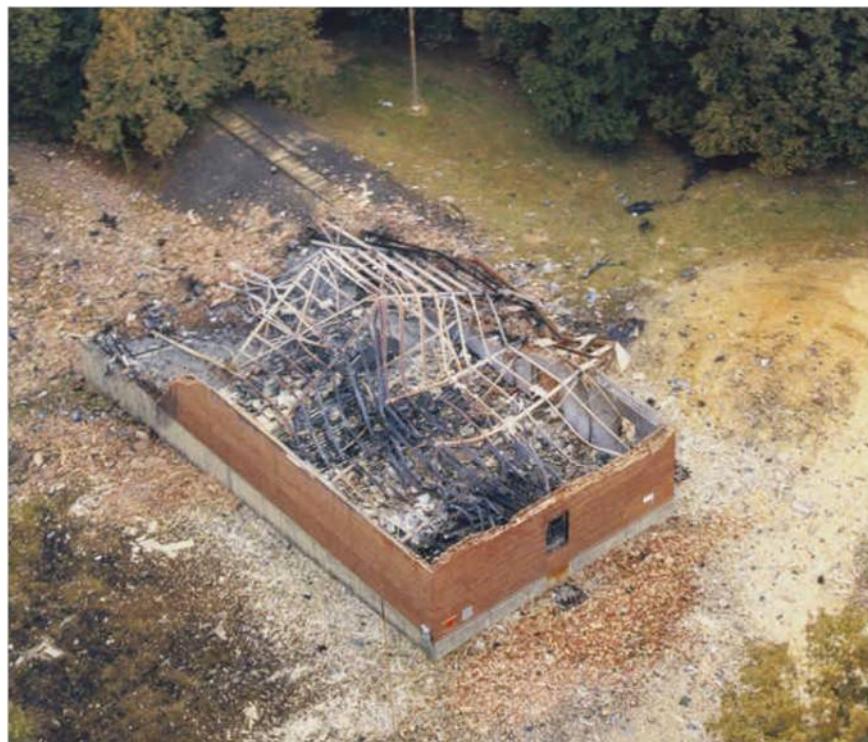
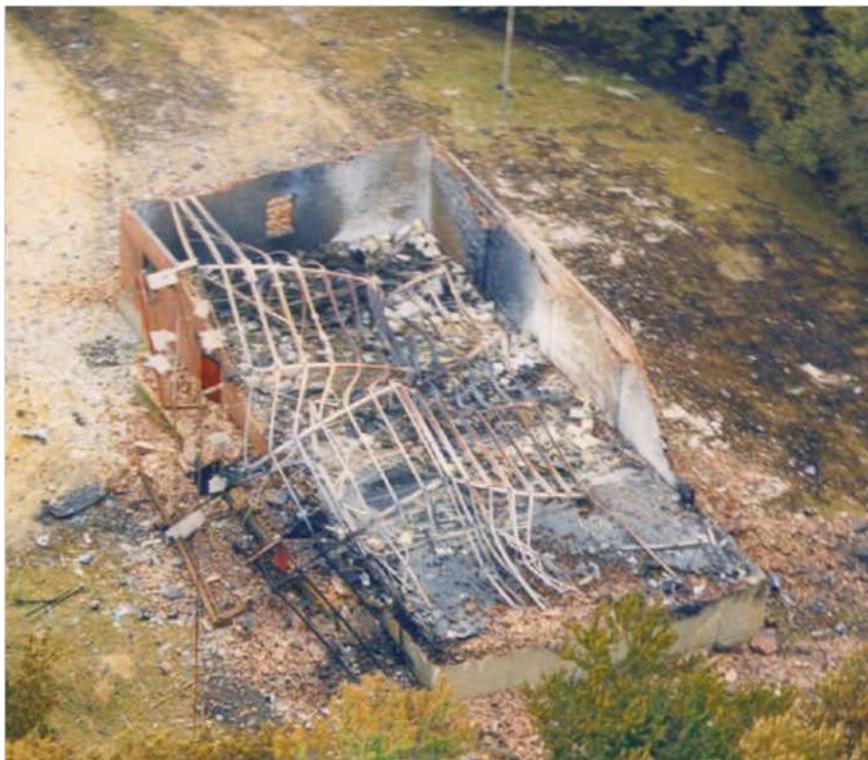
The magazine was damaged beyond economic repair but was not completely destroyed. As shown in Figure 32, the south wall was completely destroyed as was approximately two-thirds of the west wall and one-third of the east wall (the portions that were adjacent to the south wall).

An oblong crater, approximately 7 feet east-to-west and 4 feet north-to south and 3 feet deep at the center, was formed at the southeast corner of the building. In addition, there were smaller craters along the entire width of the south wall. The floor was depressed along the entire width of the south wall.

FIGURE 32. Magazine 518 After the Accident of 1 August 1994.

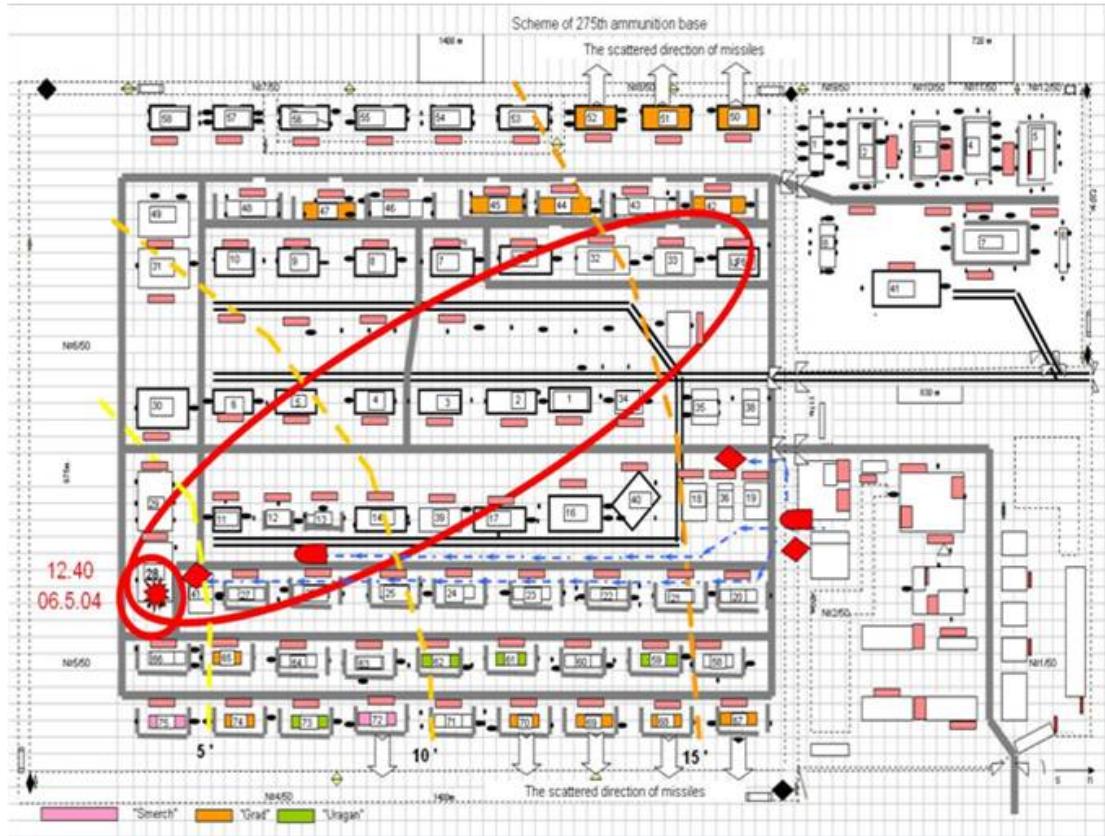
FIGURE 33. Schematic of the 275<sup>th</sup> Ammunition Base Showing the Storage Locations and the Weapon Types Stored in the Various Areas. The fire started in storage area 28, an area for demilitarization operations.

Figure 33 shows the storage locations and the weapons stored in the various locations. The fire started in storage area 28. The “Smerch” refers to 300-mm caliber multiple launcher rocket system having a range of between 20 and 70 kilometers. The “Grad” refers to a 122-mm caliber multiple-launch rocket system having a range between 1.6 and 20.4 kilometers. The “Uragan” refers to a 220-mm caliber multiple-launch rocket system having a range between 8 and 35.8 kilometers.
